BRE Global Trails Report

Summary of Findings from Ultimate Fire Pump Skid Project

Report Number: P105650-1000 Issue: 1

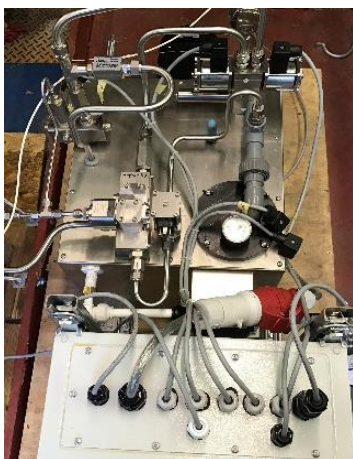
Photograph 1 – Plan view

Photograph 1 and 2 show the initial installation of the unit.

To facilitate the cycling trials a solenoid valve was added to the inlet line.

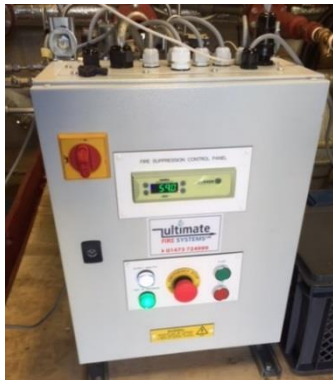
Outcome: The pump skid stopped operation after 59 cycles. Investigation by the client showed that the system circuit breaker was activated and switched the unit off. Photographs 3 and 4 shows the system post run.

Modifications: Following this run the main supply was changed by the client to increase the available current to address the addition of the extra solenoid valve which had been added to the unit as part of the trials set up.

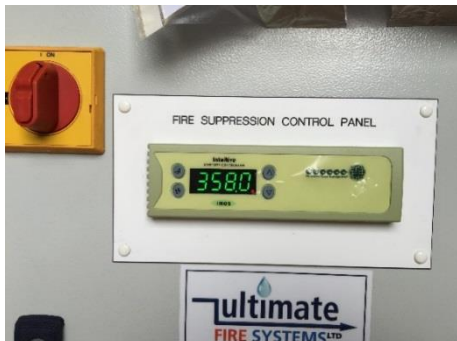
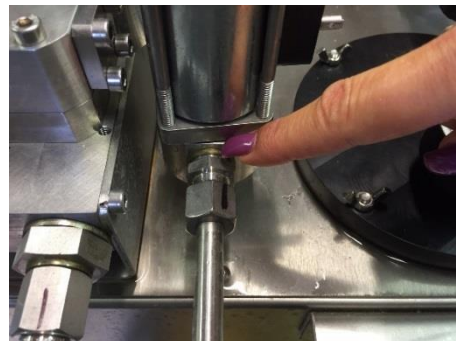
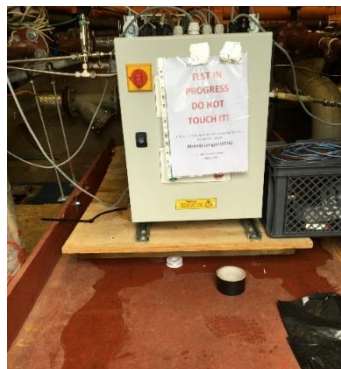
Outcome: The pump skid was manually stopped by BRE staff at 358 cycles due to leakage at the valve on the weekly test line. Photographs 5, 6 and 7 shows the unit post run.

Modifications: The client removed the weekly test line from the pump skid and blanked off the connections.

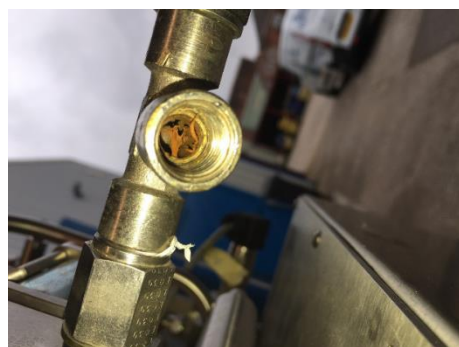
Outcome: At 620 cycles the pressure dropped outside the manufacturer`s specified figures and therefore the pump skid was manually stopped by BRE staff and the unit was collected for inspection by Water Hydraulics Co. Ltd.

Investigation: Water Hydraulics investigation reported that the pressure drop was from the distribution line. It was noted that the fittings used for the transducers supplied by BRE Global were not stainless steel and maybe the cause of the leak. Inspection report reference IR – OA5832 – 509-002.880, dated **21/09/2016**, signed by Ed Hasnip was supplied to BRE by the client **23/09/2016**. Photograph 8 and 9 shows the fitting post run.

Following the inspection detailed in Run 3 (1000 runtime cycle of Run 1 under Trial one), the pressure transducer fittings were replaced, and the weekly test line that was removed following Run 2 was re-instated by Water Hydraulics Co. Ltd. The pump skid unit was then reinstalled onto the BRE pump tank test facility by the client on **11/10/2016**.

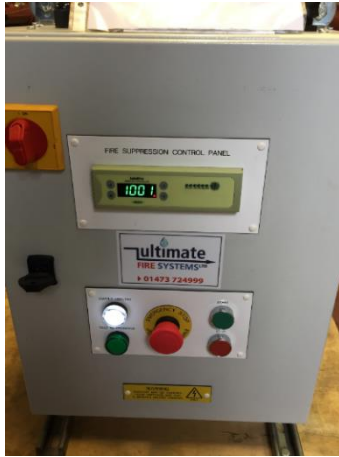
Outcome: The pump skid achieved the specified 1000 cycles. Photographs 10 and 11 shows the unit post run.

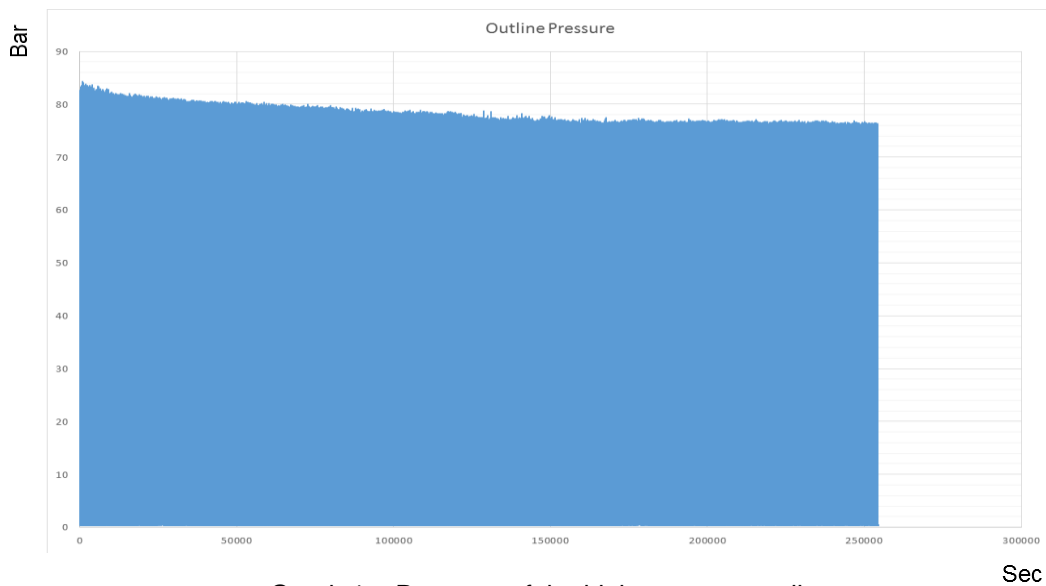
Graphs 1, 2 and 3 shows the pressure values recorded during the second cycling trial.

Graph 1 – Pressure of the high-pressure outline

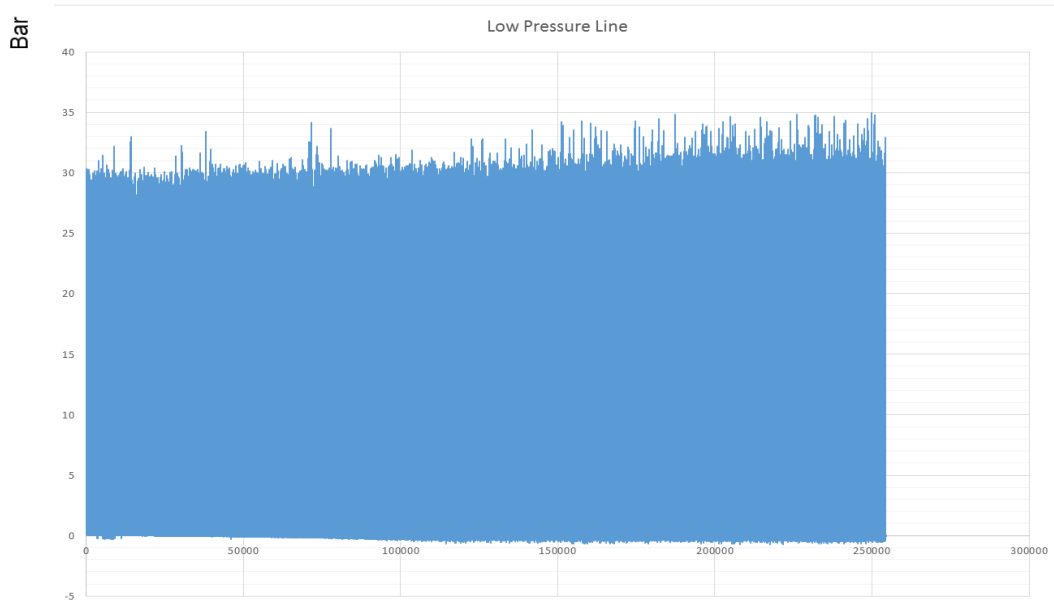
Graph 2 – Pressure of the low-pressure outline

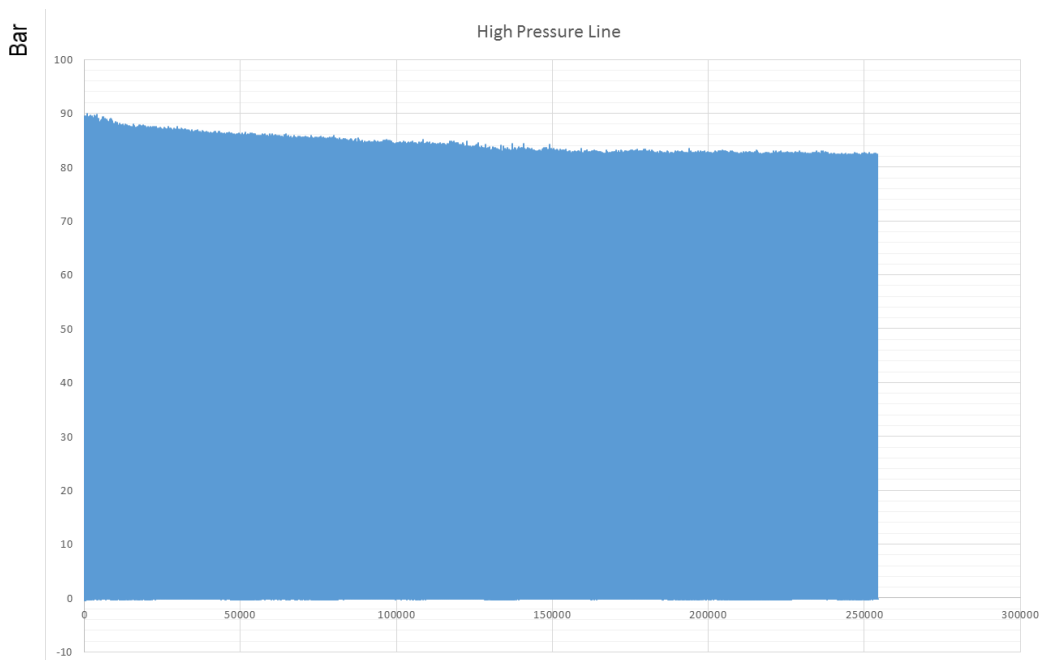
Graph 3 – Pressure of the high-pressure line

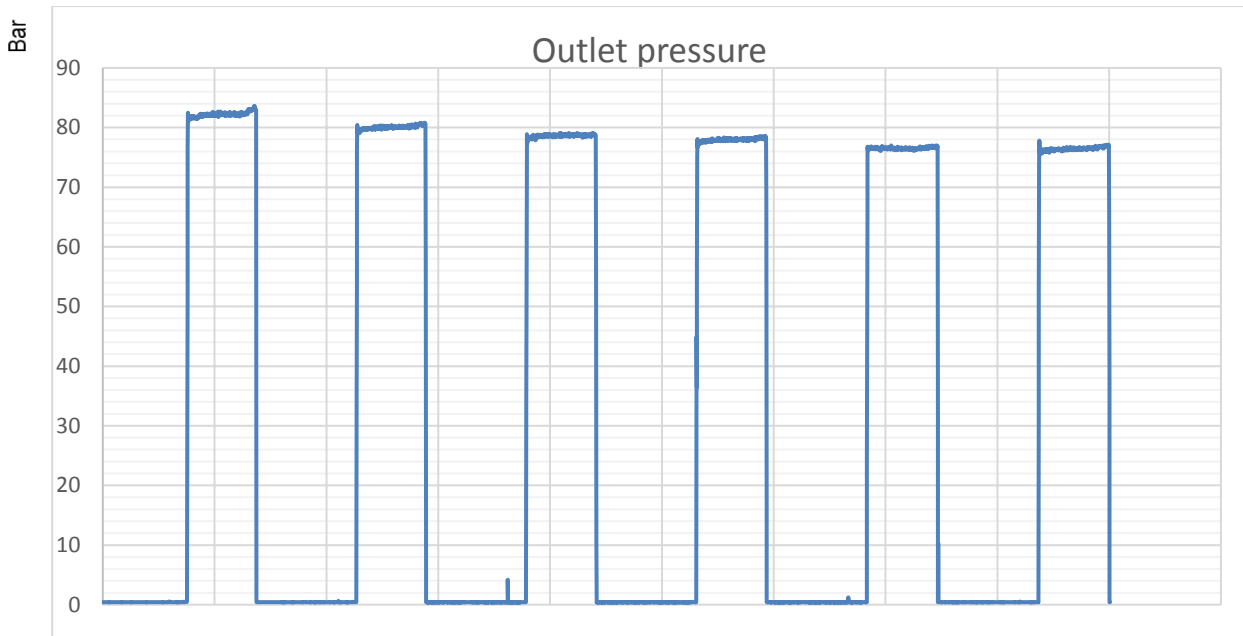
As an example of typical pressure cycles recorded, Graphs 4, 5 and 6 show the pressure values of the first and the last cycle from the sequence, together with four intermediate points which were monitored and logged by the pressure transducers detailed in this report.

Graph 4 – Pressure of the high-pressure outline

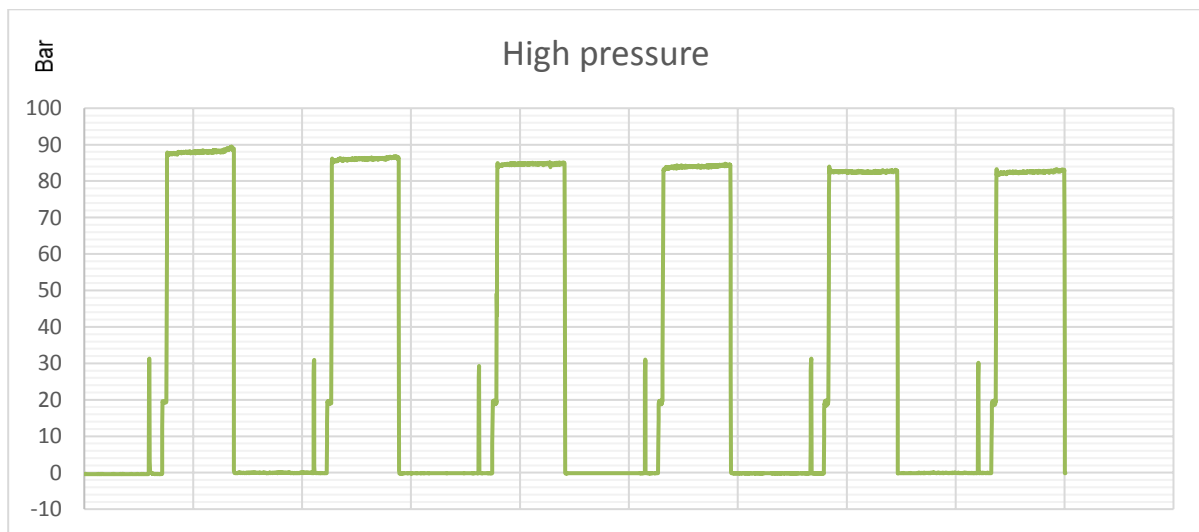
Graph 5 – Pressure of the high-pressure line

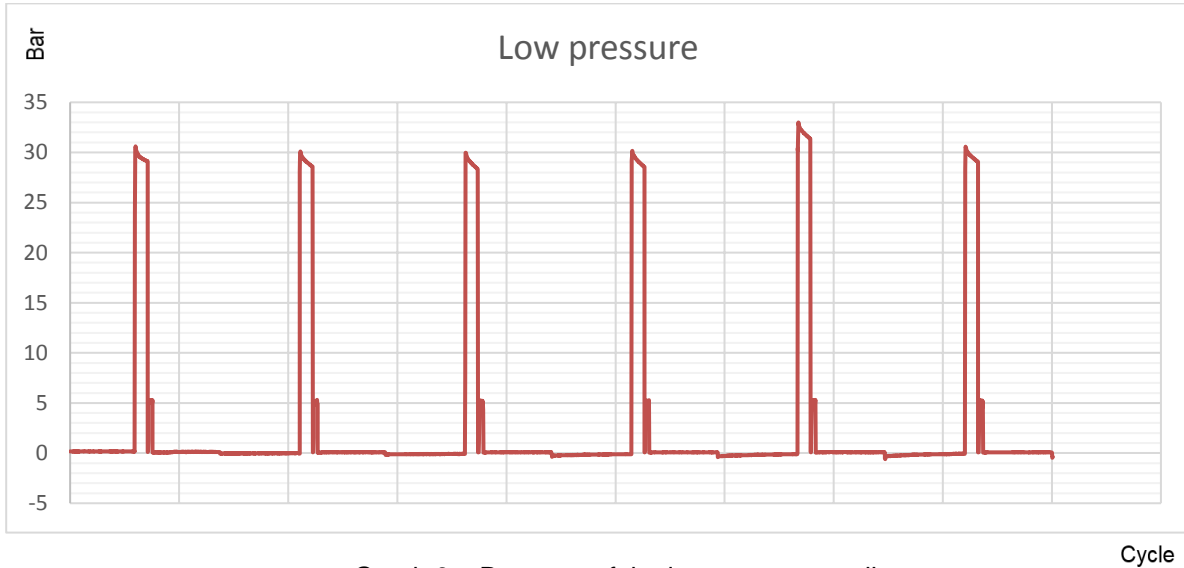
Graph 6 – Pressure of the low-pressure outline

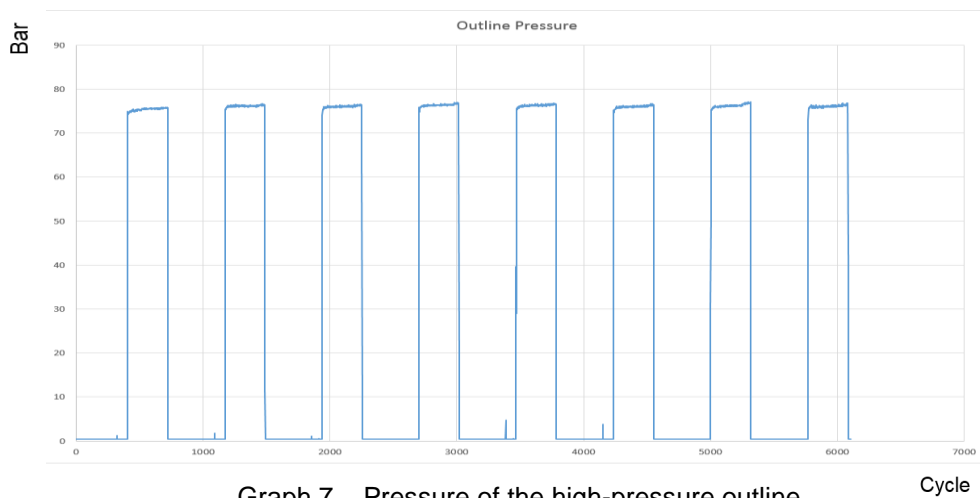
Graphs 7, 8 and 9 shows the pressure values of an additional 8 cycles post the completion of the 1000 cycle run. This was conducted on **25/10/2016**, 3 days after the 1000 cycles have been completed. The pressure values were monitored and logged by pressure transducers detailed in this report.

Graph 7 – Pressure of the high-pressure outline

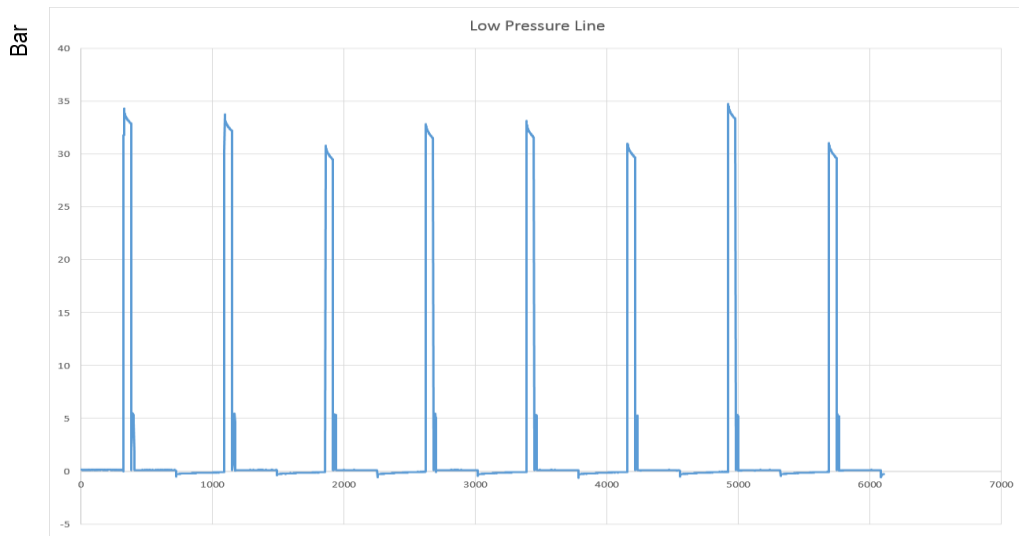
Graph 8 – Pressure of the low-pressure outline

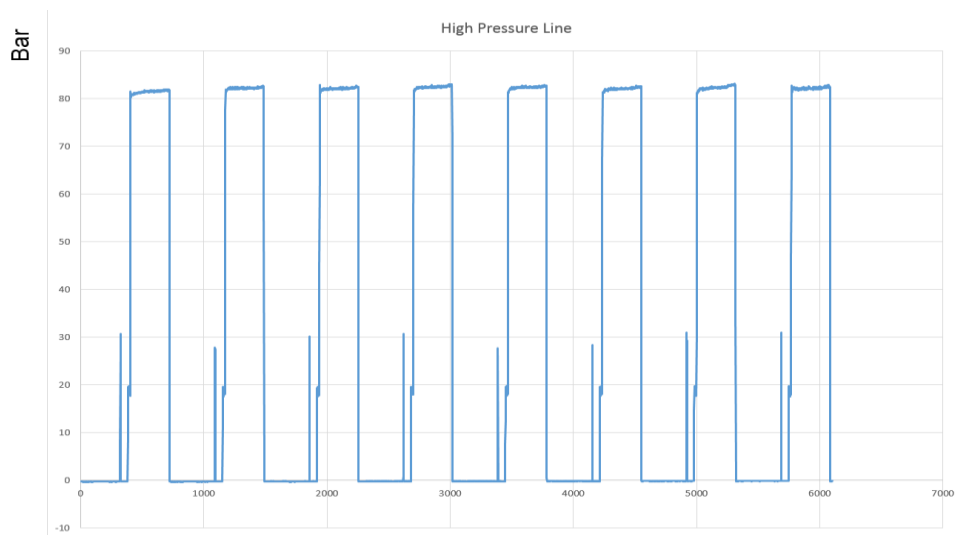
Graph 9 – Pressure of the high-pressure line

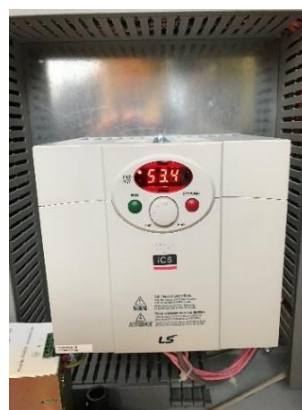
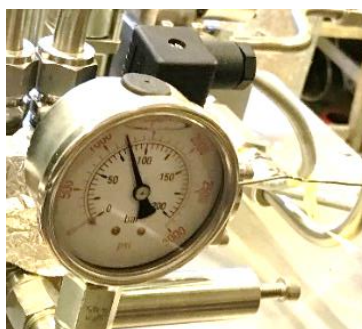
Photograph 12 shows the timing of the trial. Photograph 13 shows the inverter set up for the trial. Photograph 14 shows the pressure gauge of the pump skid unit during the trial. Photograph 15 shows the parameters of the controller set up for the trial.

Outcome: There was no leakage or damage observed to the unit or its components during or resulting from the 2-hour run trial.

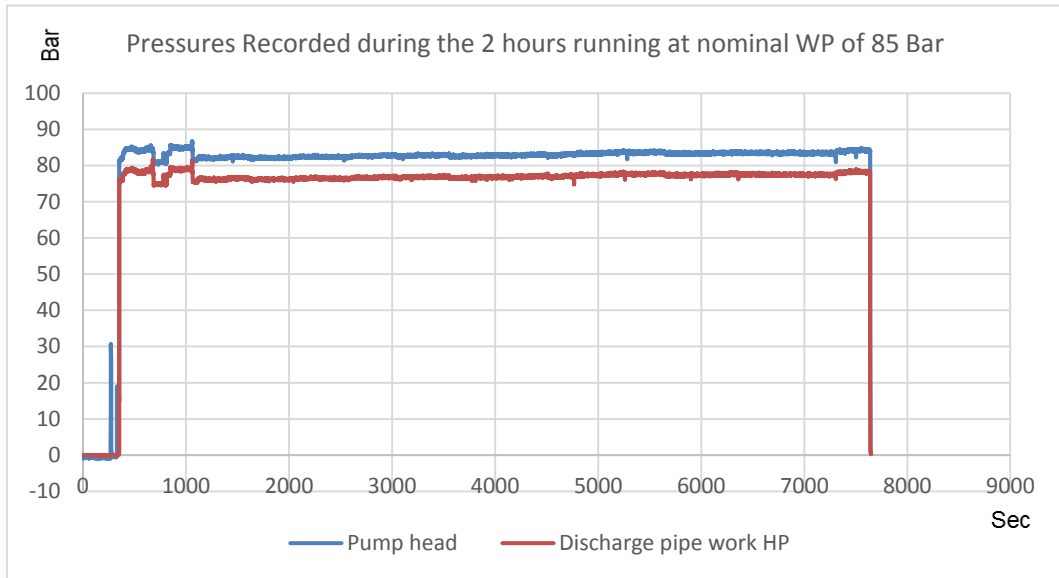
Graph 10 shows the pressure values of the pump head and of the discharge pipe work at the high-pressure line, which were monitored and logged by the pressure transducers detailed in this report.

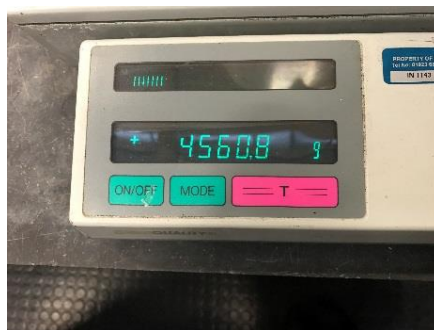
Photograph 16 shows the weight of discharged water from the first system run was 4561g.

- Run 1 – 4,6 litres/minute
- Run 2 – 4,6 litres/minute.

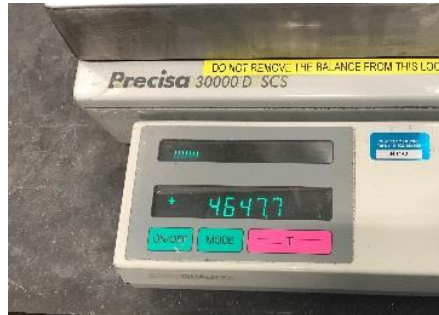
Photograph 17 shows the weight of discharged water from the second system run was 4648g.

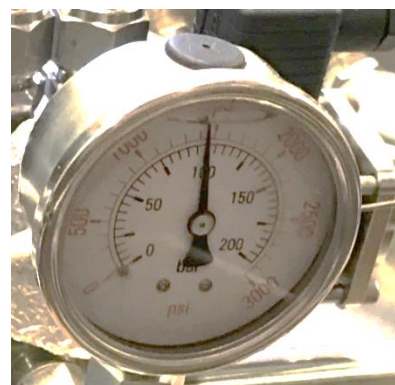
Photograph 18 shows the timing of the trial. Photograph 19 shows the pressure gauge of the pump skid unit during the trial.

Outcome: There was no leakage or damage evident during the 15 minutes run time.

Modifications: To achieve the required pressure of 99 Bar, the pressure relief valve at the pump head was adjusted by Water Hydraulics on behalf of the client.

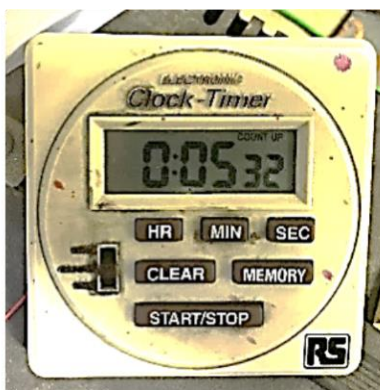
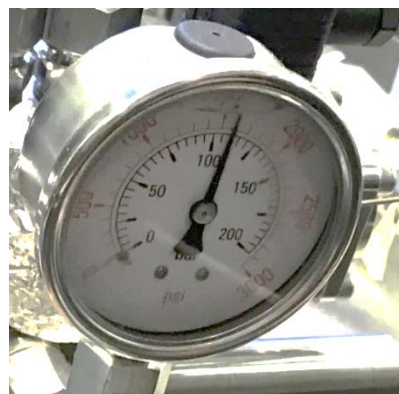
Photograph 20 shows the timing of the trial. Photograph 21 shows the pressure gauge of the pump skid unit during the trial.

Outcome: There was no leakage or damage observed during the 5 minutes run time.

Modifications: To achieve the required pressure, the pressure relief valve at the pump head was adjusted by Water Hydraulics. The pump skid unit was blanked off at the discharge pipe line (high pressure).

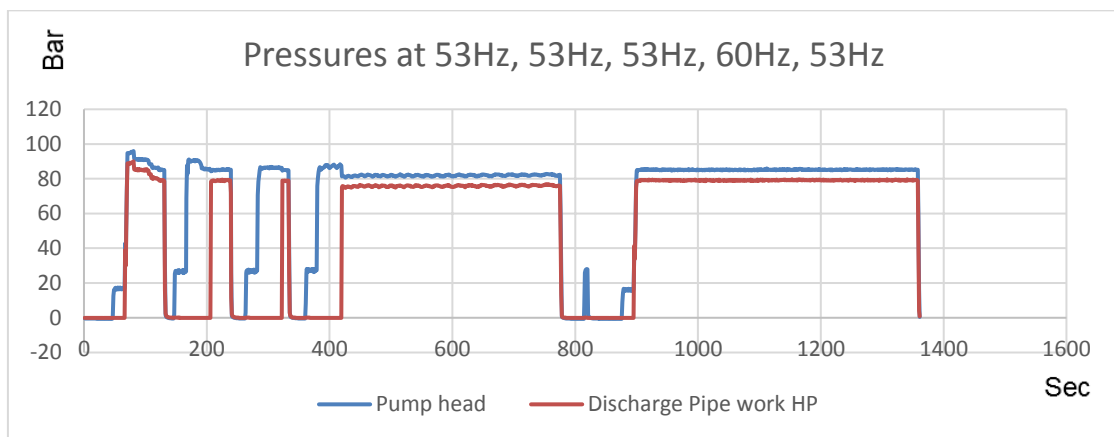
Description: The invertor was run through a series of cycles at differing frequencies and the pressure the system pressures were monitored, Graph 13. The pressure relief valve of the pump skid unit head was re-set prior to the start of the sequence.

- Initial step; the frequency of the invertor set to the original 53Hz, refer to the first three peaks of Graph 13.
- The frequency was then increased to 60Hz and the run for 7 minutes; refers to the fourth peak in the Graph 13.
- Final step; the frequency was dropped back to 53Hz, the sample was run for a further 7 minutes, refers to the fifth peak of Graph 13.

Graph 13 shows the recorded pressures at the pump head and discharge pipe work for the high-pressure line, which were monitored and logged by the pressure transducers detailed in this report.
